3.0 AFFECTED ENVIRONMENT

The Project area consists of 1.9 miles of beach within the Town of Palm Beach, Florida immediately south of Sloan's Curve. Three miles north of the Project area between Sloan's Curve and Mid-Town Beach, the shoreline has a variety of armoring structures including rock revetments, seawalls, and groins. The combined effects of these structures and the construction of the jetties at Lake Worth Inlet in 1925 have caused a longshore transport deficit to the Project area, which has resulted in erosion and exposure of nearshore hardbottom.

Phipps Ocean Park Beach Restoration Project		PLAN VIEW		Figure 3.1
COASTAL TECH		LAKESIDE DIST. TO SOUTH LAKESIDE		JOB NO.
VENO BEACH, MINNESOTA, MINNESOTA, MINNESOTA		REVISION		DATE
		MPW		4/2/2002
				93714

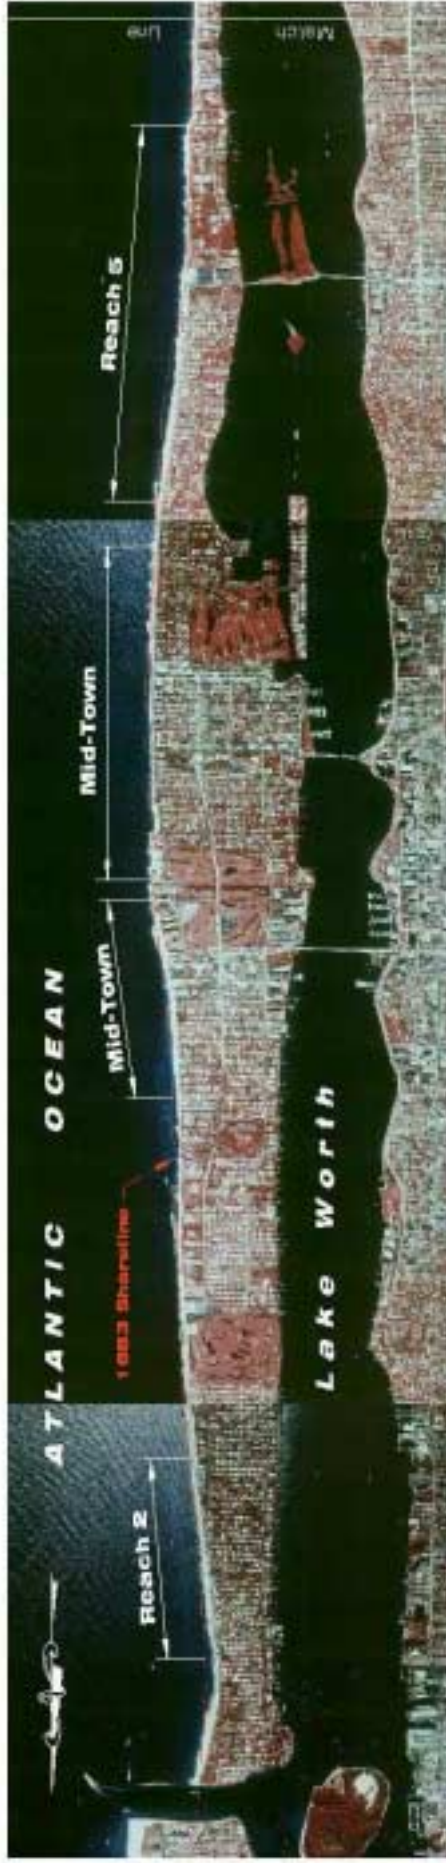
Figure 3.1 illustrates the configuration of the shoreline and fill areas, as proposed by the Town of Palm Beach, from Lake Worth Inlet to South Lake Worth Inlet.

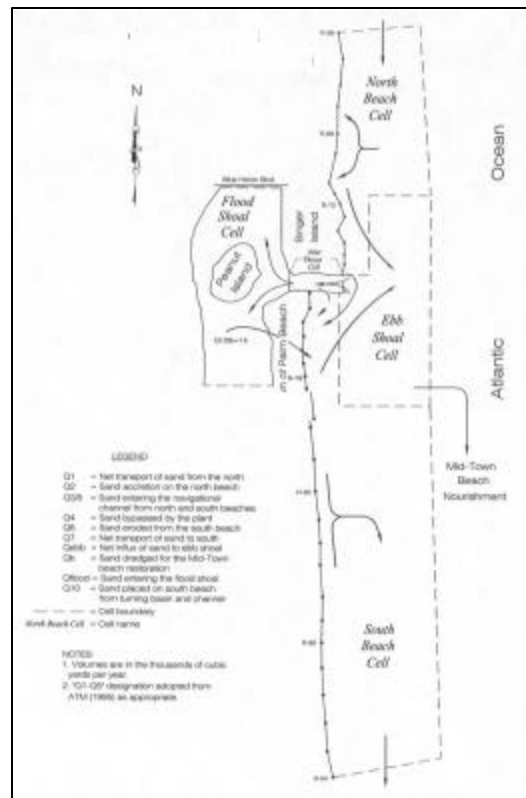
Figure 3.4 Lake Worth Inlet Sediment Budget Cells and Domain

There are five sediment sink/loss areas (Coastal Tech, 2000) which capture or release sediment that migrates through the Lake Worth Inlet coastal domain in response to coastal processes and mechanical transfer :

- (1) north beach
- (2) ebb shoal
- (3) south beach
- (4) inlet throat
- (5) flood shoal

Between 1998 and 2000, the Town conducted monitoring surveys of the Inlet domain. Based on these and previous surveys conducted in 1994, the Inlet’s sediment budget was estimated for the period from 1994 to 2000. Regarding the Inlet’s sediment pathways and cells, the Inlet’s north beach, ebb shoal, throat, and flood shoal act as sediment sinks (Figure 3.4). USACE maintenance dredging and the sand transfer plant have partially offset Inlet impacts from 1994 to 2000.

The following summarizes the sediment budget of Lake Worth Inlet as estimated for the period from 1994 to 2000.

North Beach: Based solely on the surveys, the volume changes on the north beach averaged a loss of approximately 25,100 cy/yr. The average annual volume of mechanical transfer at the sand transfer plant was 182,100 cy/yr during this period. Plant operation was restarted in May 1996 after being shutdown in 1990. Based on the surveys and transfer data, about 157,000 cy/yr are estimated to deposit on the north beach.

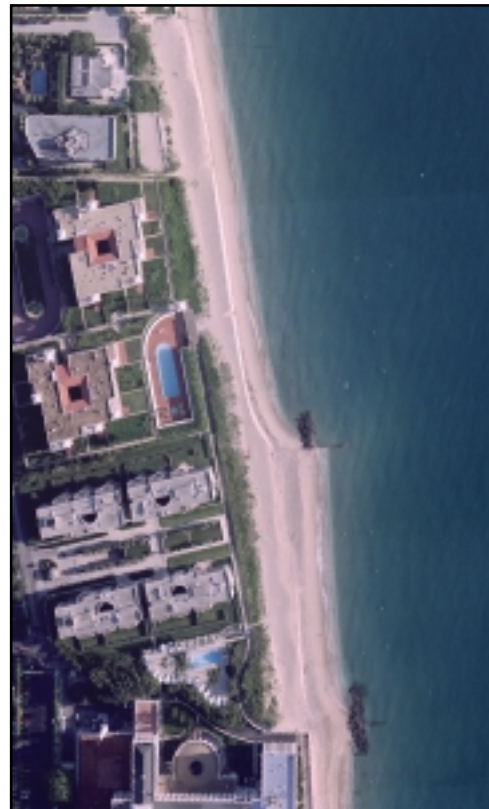
Figure 3. 10 Aerial Photograph of Reach 3 at Breakers Hotel (March 2001)

Reach 3: Reach 3 extends over 5,800 feet of shoreline and is almost completely fronted by seawalls (ATM, 1998). The southern end of Reach 3 includes several groins at the north end of the Breakers Hotel (Figure 3.10). The seawalls and groins can deter updrift erosion and translate the longshore transport deficit to downdrift beaches.

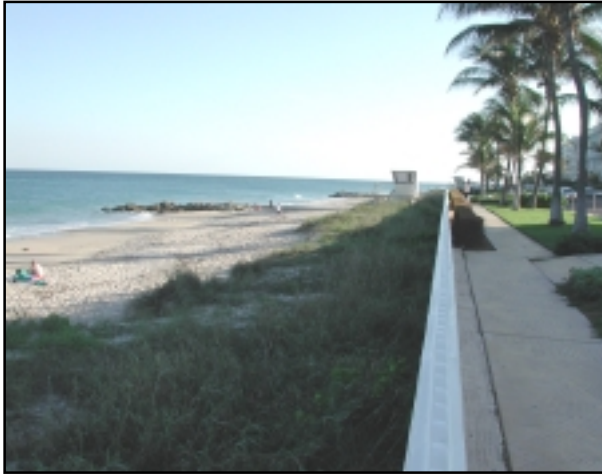
Figure 3. 11 The Mid-Town Region of Reach 4 (February 2002)

Reach 4: By 1987, over 80% of the shoreline in Reach 4 was fronted by a seawall (Figure 3.11). Virtually the entire shoreline included groins (Olsen, 1987). In December 1995, the Mid-Town Beach Restoration project was completed in Reach 4 (Dean, 1997). About 800,000 cubic yards of sand were placed on the beach between Monuments R-95 and R-100. The fill area includes a groin field constructed from coquina rock and from concrete “PEP reef” units obtained from a previous experimental project.

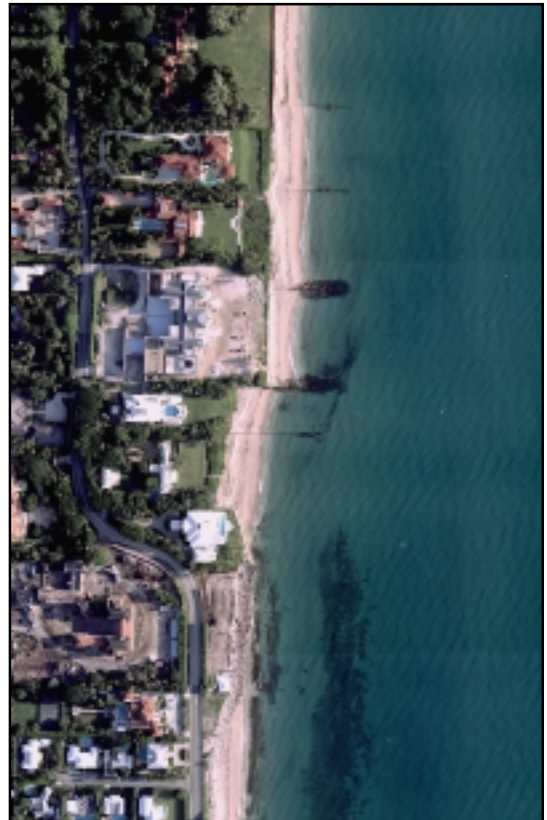
Figure 3. 12 Aerial Photograph of Reach 5 at Widener's Curve (March 2001)

Reach 5: By 1987, over 80% of the shoreline in Reach 5 was fronted by a seawall or a rock revetment. The entire shoreline included groins (Olsen, 1987) which have significantly affected the shoreline (Figure 3.12). The “Monster Groin” (near R-110) improves the stability of the shoreline to the north in Reach 5, but deprives sand to the downdrift beaches in Reach 6.

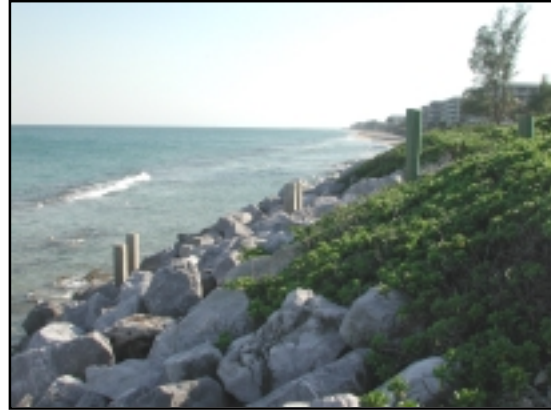
Figure 3. 13 Rock and Groins in Reach 6 (February 2001)

In 1987, the FDOT constructed a rock revetment along the shoreline in Reach 6 (Figure 3.13). The rock revetment and groins have “hardened” the shoreline, deprived the downdrift beaches of sand, and translated the longshore transport deficit. The volume change data indicate that Reach 6 eroded at about 7,500, 15,000, and 46,000 cy/yr from 1929 to 1957, 1974 to 1990, and 1990 to 1997, respectively.

Without placement of additional sand fill, the Town's beaches are expected to continue to erode to the face of the existing seawalls and revetments. This condition now exists in Reach 6 (Figure 3.13 and description for Reach 6). Sand placed in Reach 1 is expected to work its way downdrift to South Lake Worth Inlet through littoral processes.

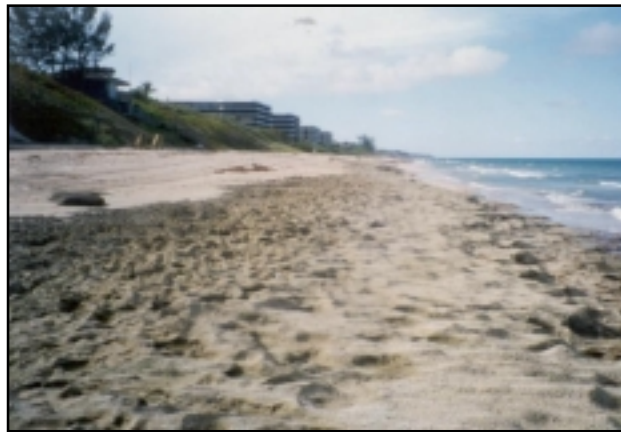
Figure 3. 14 Exposed Anastasia Formation in Reach 7

Reach 7: Sloan’s Curve is located at the northern boundary of Reach 7. The 3 miles of shoreline immediately north of Sloan’s Curve and Reach 7 are fronted by numerous armoring structures including rock revetments, seawalls, and groins. The Mid-Town Beach Restoration Project is located to the north of this 3 mile segment. In combination with the effects of Lake Worth Inlet, the armoring structures along this 3 mile segment have caused a longshore transport and sediment deficit to the proposed Project area. The resulting erosion has exposed the Anastasia Formation in the form of nearshore hardbottom and emergent rock (Figure 3.14).

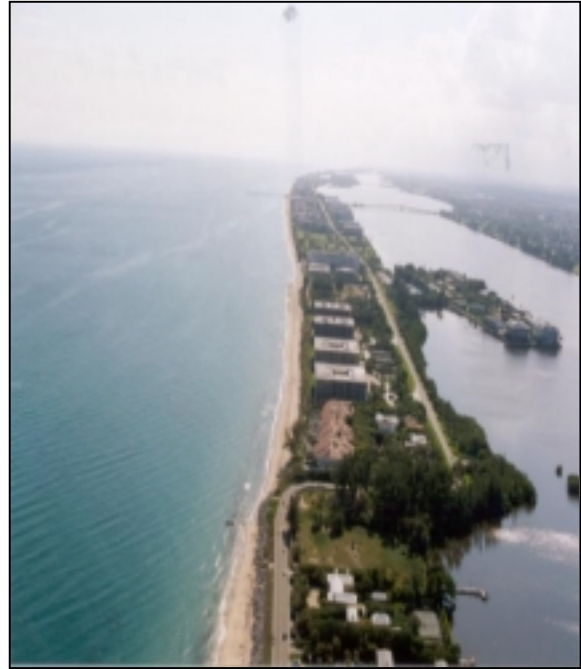
Figure 3.15 Oblique Aerial Photograph of the Concave Shoreline in Reach 7 (1999)

Prior to construction of Lake Worth Inlet in 1925, FDEP historical shoreline data indicate that the shoreline was significantly more seaward than its present position. In the vicinity of the proposed Phipps Ocean Park Project (R-120 to R-122), the shoreline has receded by about 200 feet since 1878. This recession has resulted in the current “concave” shoreline where the shorelines at the north and southern boundaries are further east than at the mid-point (Figure 3.15).

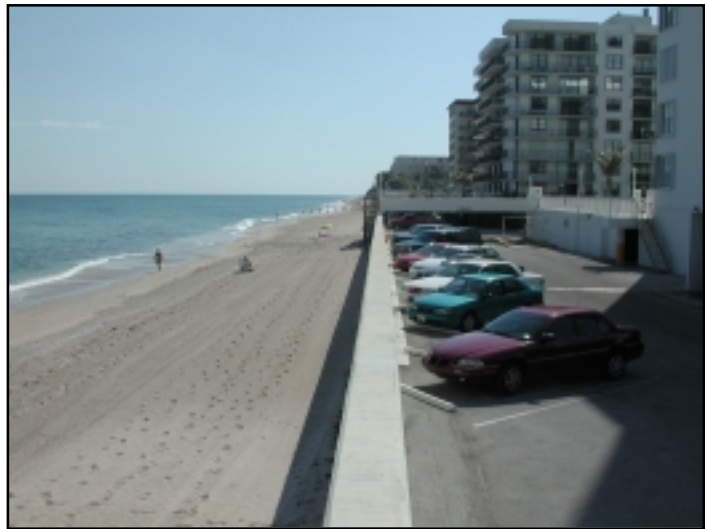
Figure 3. 17 Exposed Seawall Near R-135 (Reach 8)

Reach 8: Reach 8 is the southernmost reach within the Town of Palm Beach. By 1987 about 65% of Reach 8 was fronted by seawalls (Olsen, 1987). Many of these seawalls are now buried under the beach berm or dune such as at Lake Worth Public Beach (Figure 3.16). At the southern limits of Reach 8, the existing seawalls are located in close proximity to the shoreline (Figure 3.17).

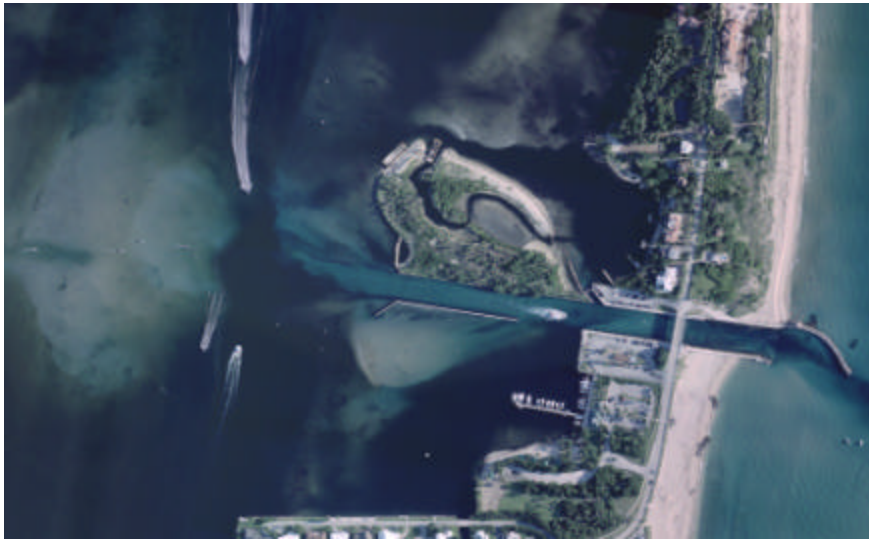
Figure 3. 19 South Lake Worth Inlet (Reach 11)

Reach 11: South Lake Worth Inlet is the southern boundary of Reach 11. By 1987 over 50% of this Reach as fronted by seawalls (Olsen, 1987). The volume change data indicate annual losses from Reach 11 at approximately 22,000 cy/yr from 1929 to 1957. Reach 11 gained sand at approximately 2,500 cy/yr between 1974 and 1990, but eroded at about 4,500 cy/yr from 1990 to 1997). The data indicate that the shoreline of Reach 11 is reasonably stable. This is apparently as a result of the updrift stabilizing influence of the north jetty at the Inlet (Figure 3.19).

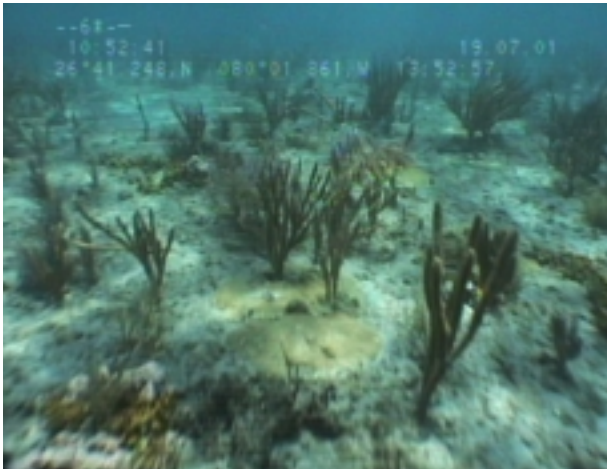
Figure 3. 22 Example of Intermediate Depth Hardbottom Habitat Captured From Towed Video Survey Near FDEP Monument R-103. Habitat Dominated by Low to Medium Profile Gorgonians and Sponges

As mentioned above, hardbottom was observed along the northernmost transects (1 through 6, DNR monuments R-113 through R-116, respectively) in water depths ranging from 1.2 to 3.0 m (4 to 10 ft). The hardbottom in this area consisted of exposed and sand veneered rock. The eastern edge of the hard bottom outcrop, which lies at the beginning of the intermediate depth zone, had the highest degree of relief, approximately 0.3 to 0.9 m (1 to 3 ft). The western edge had a relief of less than 0.6 m (2 ft). At the southern end of the hardbottom, as observed along transect 6, a thin layer of sand veneered the rock. The dominant biota on these deeper (intermediate) rock outcrops included algae, sabellariid worm rock, sponges, and soft corals (Figure 3.22).
